**Flood Control Project Maintenance
Levee Inspections**

Maintenance Issue Types Only, Levee Inspection Report By Mile - Fall 2016

Levee District No. 0003 (Glenn County)

Waterway	Bank	Unit Miles	Inspection Start/End	Inspector
Unit No. 01 Glenn County Sacramento River	Left	11.97	10/20/2016 10/20/2016	Tariq Chechi

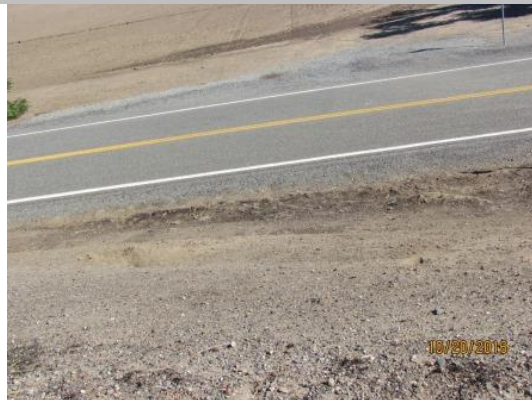
Photo 1 of 1 : FA_2016_LD0003_27_105_20161031_00097.jpg

LM Start	0.27	Rating **	M	Issue No.	105
LM End	0.27	Issue Type +	Ma	Location *	LS
Category	Earthen Levee			GPS Latitude/Longitude	
				Start	End
Item	Animal Control			39.387413 °	39.387413 °
				-121.991086 °	-121.991086 °
DWR ID	DWR_LD0003_01_f_2016_105				
Comment Code					
A3 : No rodents visible, but rodent burrows visible; need to backfill and compact or grout burrows.					
Inspector Comment

View of the rodent holes along the landside slope.

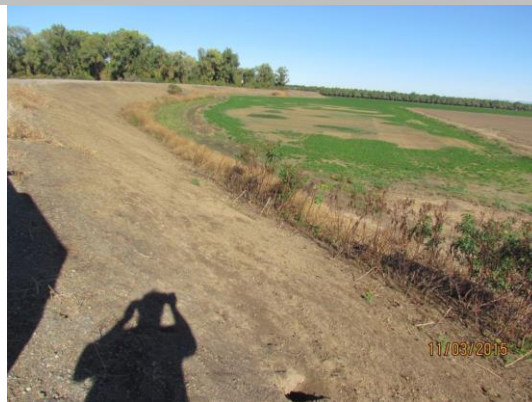
Photo 1 of 1 : FA_2016_LD0003_27_51_20160823_00031.jpg

LM Start	0.81	Rating **	U	Issue No.	51
LM End	0.91	Issue Type +	Ma	Location *	LS
Category	Earthen Levee		GPS Latitude/Longitude		
			Start	End	
Item	Animal Control		39.388690°	39.389867°	
			-121.999820°	-122.000585°	
DWR ID	DWR_LD0003_01_f_2015_51				
Comment Code					
A3 : No rodents visible, but rodent burrows visible; need to backfill and compact or grout burrows.					
Inspector Comment

View of the rodent holes along the landside slope.

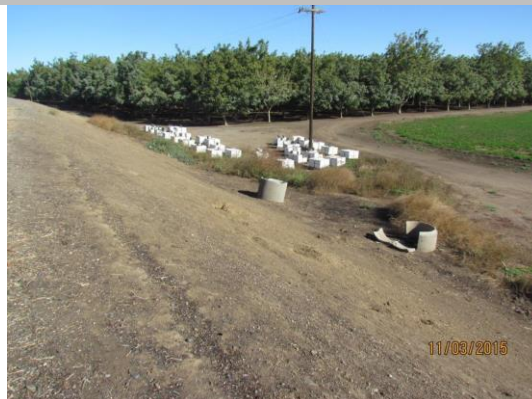
Photo 1 of 1 : FA_2016_LD0003_27_52_20160823_00032.jpg

LM Start	1.21	Rating **	M	Issue No.	52
LM End	1.21	Issue Type +	Ma	Location *	LS
Category	Earthen Levee			GPS Latitude/Longitude	
				Start	End
Item	Animal Control			39.394010 °	39.394010 °
				-122.000977 °	-122.000977 °
DWR ID	DWR_LD0003_01_f_2015_52				
Comment Code					
A3 : No rodents visible, but rodent burrows visible; need to backfill and compact or grout burrows.					
Inspector Comment

View of the rodent holes along the landside slope.

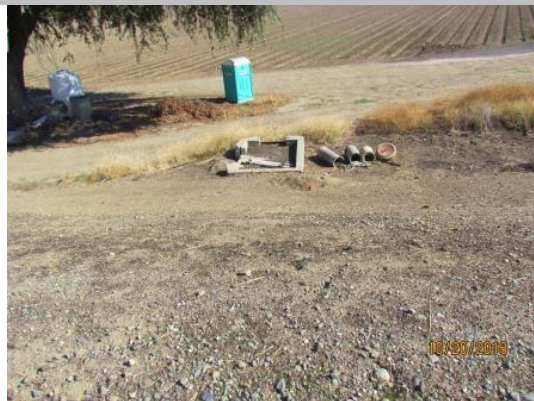
Photo 1 of 1 : FA_2016_LD0003_27_102_20161103_00100.jpg

LM Start	2.98	Rating **	M	Issue No.	102
LM End	2.98	Issue Type +	Ma	Location *	LS
Category	Earthen Levee			GPS Latitude/Longitude	
				Start	End
Item	Animal Control			39.412909 °	39.412909 °
				-121.991446 °	-121.991446 °
DWR ID	DWR_LD0003_01_f_2016_102				
Comment Code					
A1 : Exterminate rodents and backfill and compact or grout burrows.					
Inspector Comment

View of the rodent holes along the landside slope.

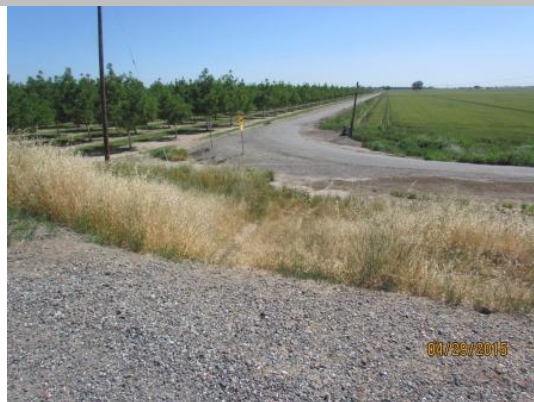
Photo 1 of 1 : FA_2016_LD0003_27_9_20160823_00005.jpg

LM Start	3.39	Rating **	M	Issue No.	9
LM End	3.39	Issue Type +	Ma	Location *	LS
Category	Earthen Levee			GPS Latitude/Longitude	
				Start	End
Item	Slope Stability			39.418382 °	39.418382 °
				-121.992480 °	-121.992480 °
DWR ID	DWR_LD0003_01_s_2012_9				
Comment Code					
S3 : Repair the levee slope damaged by vehicle traffic and prevent access where possible.					
Inspector Comment					
Repair the erosion along the landside slope and prevent vehicle access

View of the vehicle erosion along the landside slope.

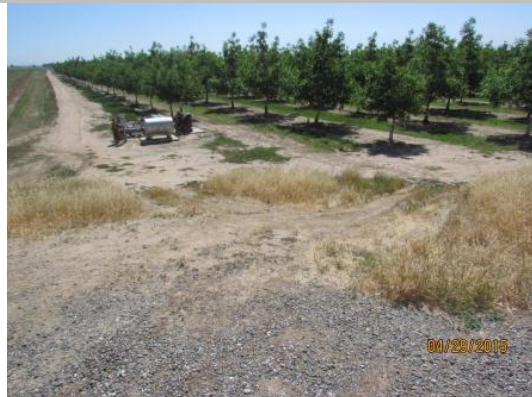
Photo 1 of 1 : FA_2016_LD0003_27_19_20160823_00013.jpg

LM Start	3.76	Rating **	M	Issue No.	19
LM End	3.76	Issue Type +	Ma	Location *	LS
Category	Earthen Levee			GPS Latitude/Longitude	
				Start	End
Item	Slope Stability			39.423747 °	39.423747 °
				-121.991667 °	-121.991667 °
DWR ID	DWR_LD0003_01_s_2012_19				
Comment Code					
S3 : Repair the levee slope damaged by vehicle traffic and prevent access where possible.					
Inspector Comment

View of the vehicle erosion along the landside slope.

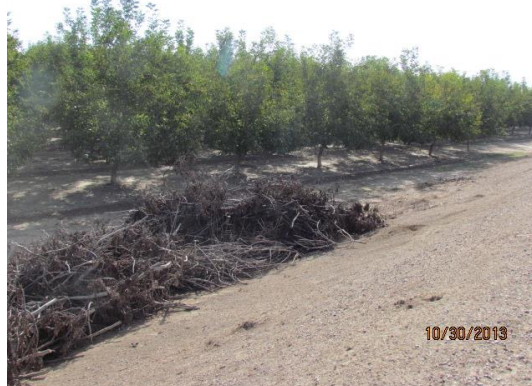
Photo 1 of 1 : FA_2016_LD0003_27_63_20160823_00041.jpg

LM Start	4.66	Rating **	M	Issue No.	63
LM End	4.66	Issue Type +	Ma	Location *	LS
Category	Earthen Levee			GPS Latitude/Longitude	
				Start	End
Item	Encroachments			39.435701°	39.435701°
				-121.988189°	-121.988189°
DWR ID	DWR_LD0003_01_f_2013_63				
Comment Code					
PR : Prunings					
Inspector Comment					
Remove the prunings from the landside toe.

View of the prunings along the landside toe.

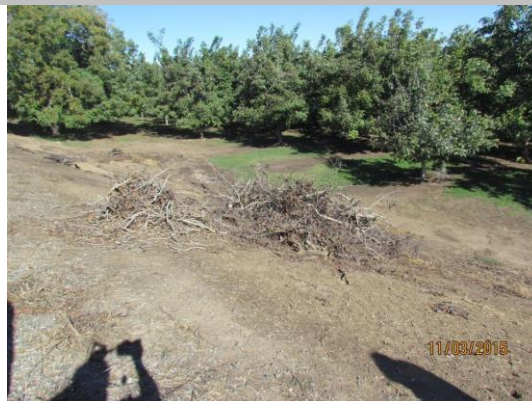
Photo 1 of 1 : FA_2016_LD0003_27_69_20160823_00046.jpg

LM Start	5.06	Rating **	M	Issue No.	69
LM End	5.06	Issue Type +	Ma	Location *	LS
Category	Earthen Levee			GPS Latitude/Longitude	
				Start	End
Item	Encroachments			39.441057 °	39.441057 °
				-121.990458 °	-121.990458 °
DWR ID	DWR_LD0003_01_f_2015_69				
Comment Code					
PR : Prunings					
Inspector Comment					
Remove the prunings from the landside slope.

View of the prunings along the landside slope.

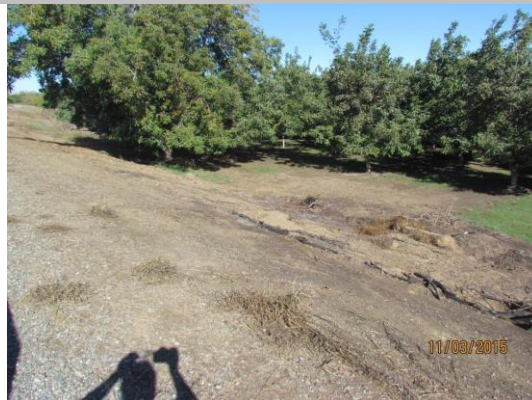
Photo 1 of 1 : FA_2016_LD0003_27_21_20160823_00015.jpg

LM Start	5.06	Rating **	U	Issue No.	21
LM End	5.25	Issue Type +	Ma	Location *	LS
Category	Earthen Levee			GPS Latitude/Longitude	
				Start	End
Item	Animal Control			39.441128 °	39.443793 °
				-121.990475 °	-121.991297 °
DWR ID	DWR_LD0003_01_f_2015_21				
Comment Code					
A3 : No rodents visible, but rodent burrows visible; need to backfill and compact or grout burrows.					
Inspector Comment

View of the rodent holes along the landside slope.

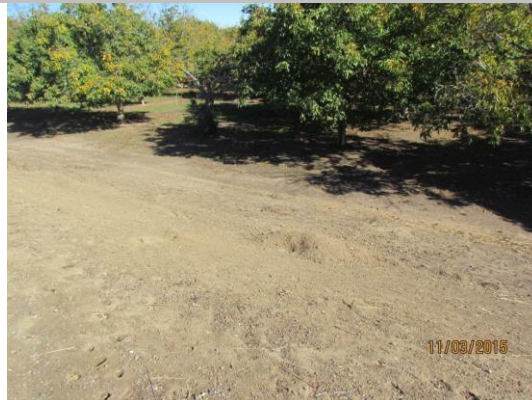
Photo 1 of 1 : FA_2016_LD0003_27_70_20160823_00047.jpg

LM Start	5.38	Rating **	U	Issue No.	70
LM End	5.39	Issue Type +	Ma	Location *	LS
Category	Earthen Levee			GPS Latitude/Longitude	
				Start	End
Item	Animal Control			39.445619 °	39.445808 °
				-121.991510 °	-121.991552 °
DWR ID	DWR_LD0003_01_f_2015_70				
Comment Code					
A3 : No rodents visible, but rodent burrows visible; need to backfill and compact or grout burrows.					
Inspector Comment

View of the rodent holes along the landside slope.

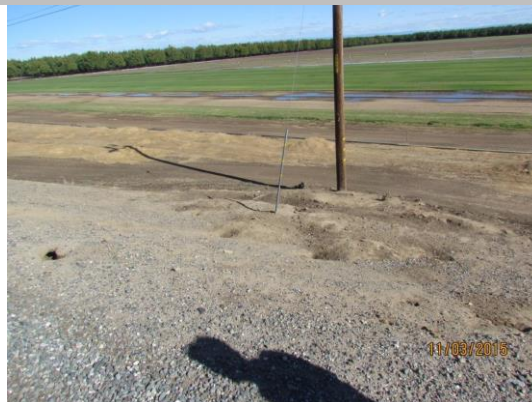
Photo 1 of 1 : FA_2016_LD0003_27_71_20160823_00048.jpg

Comment Code					
A3 : No rodents visible, but rodent burrows visible; need to backfill and compact or grout burrows.					
Inspector Comment

View of the rodent holes along the landside slope.

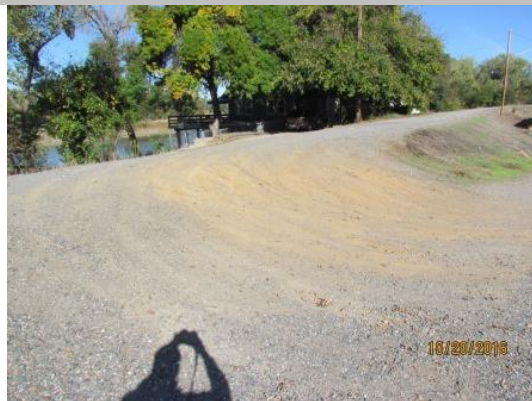
Photo 1 of 1 : FA_2016_LD0003_27_34_20161103_00103.jpg

LM Start	6.57	Rating **	M	Issue No.	34
LM End	6.57	Issue Type +	Ma	Location *	LS
Category	Earthen Levee			GPS Latitude/Longitude	
				Start	End
Item	Slope Stability			39.462505 °	39.462505 °
				-121.992698 °	-121.992698 °
DWR ID	DWR_LD0003_01_s_2012_34				
Comment Code					
S3 : Repair the levee slope damaged by vehicle traffic and prevent access where possible.					
Inspector Comment

View of slope instability caused by vehicle traffic.

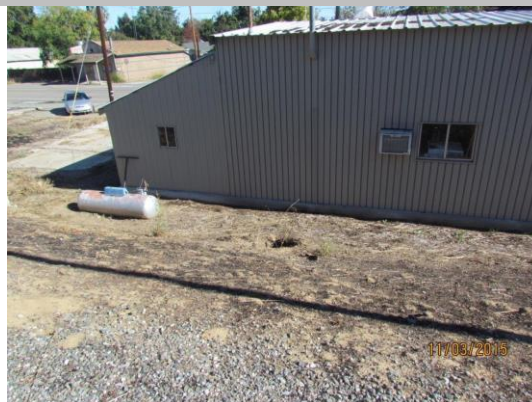
Photo 1 of 1 : FA_2016_LD0003_27_76_20160823_00053.jpg

LM Start	6.61	Rating **	U	Issue No.	76
LM End	6.61	Issue Type +	Ma	Location *	LS
Category	Earthen Levee			GPS Latitude/Longitude	
				Start	End
Item	Trim / Thin Trees			39.463185 °	39.463185 °
				-121.992657 °	-121.992657 °
DWR ID	DWR_LD0003_01_f_2015_76				
Comment Code					
T5 : Tree stumps.					
Inspector Comment					
Repair the burned out stump hole along the landside toe.

View of the burned out stump hole along the landside toe.

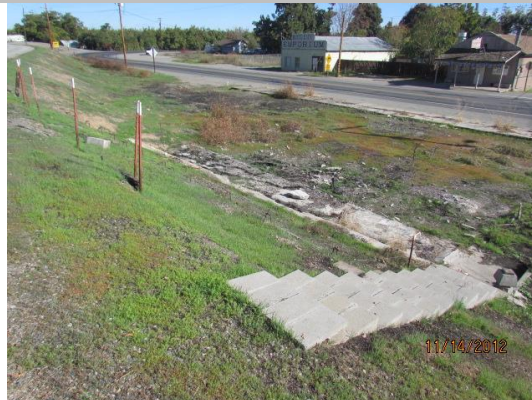
Photo 1 of 1 : FA_2016_LD0003_27_12_20160823_00009.jpg

LM Start	6.63	Rating **	M	Issue No.	12
LM End	6.63	Issue Type +	Ma	Location *	LS
Category	Earthen Levee			GPS Latitude/Longitude	
				Start	End
Item	Slope Stability			39.463366 °	39.463366 °
				-121.992586 °	-121.992586 °
DWR ID	DWR_LD0003_01_f_2012_12				
Comment Code					
S1 : Repair slope instability.					
Inspector Comment					
Building has burned down.

View of concrete stairs & foundation along the slope of the levee.

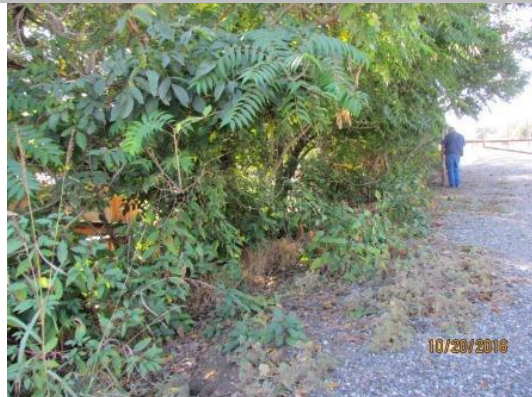
Photo 1 of 1 : FA_2016_LD0003_27_35_20161103_00104.jpg

LM Start	6.75	Rating **	M	Issue No.	35
LM End	6.75	Issue Type +	Ma	Location *	LS
Category	Earthen Levee			GPS Latitude/Longitude	
				Start	End
Item	Trim / Thin Trees			39.465013 °	39.465013 °
				-121.991455 °	-121.991455 °
DWR ID	DWR_LD0003_01_s_2012_35				
Comment Code					
T1 : Trim trees to at least five feet above ground level.					
Inspector Comment

View of the trees that are hanging over the landside slope of the levee.

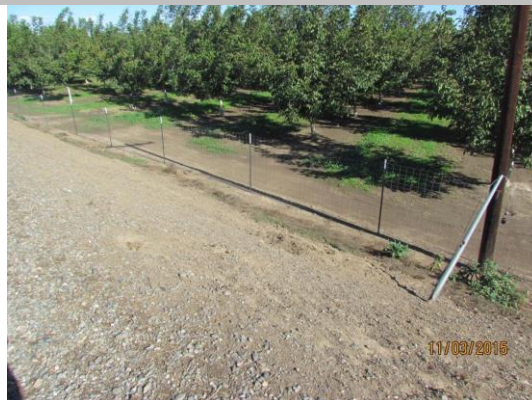
Photo 1 of 1 : FA_2016_LD0003_27_79_20160823_00056.jpg

LM Start	9.50	Rating **	U	Issue No.	79
LM End	9.50	Issue Type +	Ma	Location *	LS
Category	Earthen Levee			GPS Latitude/Longitude	
				Start	End
Item	Animal Control			39.502698 °	39.502698 °
				-121.985235 °	-121.985235 °
DWR ID	DWR_LD0003_01_f_2015_79				
Comment Code					
A3 : No rodents visible, but rodent burrows visible; need to backfill and compact or grout burrows.					
Inspector Comment

View of the rodent holes along the landside slope.

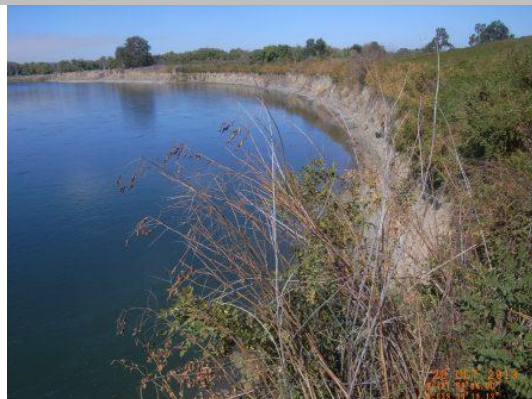
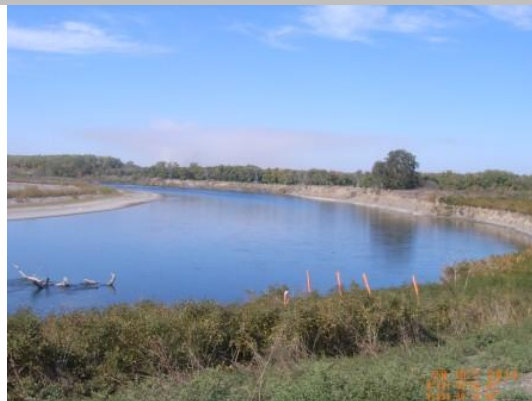
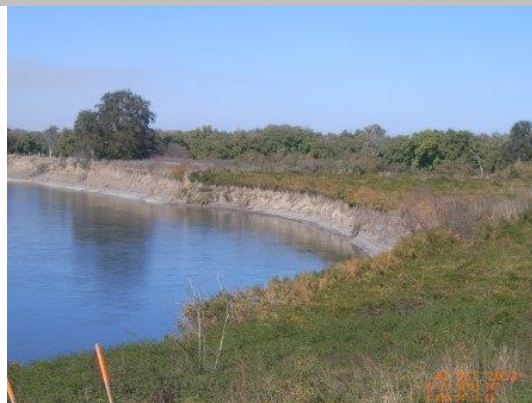
LM Start	9.61	Rating **	M	Issue No.	10
LM End	9.88	Issue Type +	Ma	Location *	WS
Category	Supplemental			GPS Latitude/Longitude	
				Start	End
Item	2015 USACE Erosion Survey, DRAFT			39.504388 °	39.508117 °
				-121.985301 °	-121.986562 °
DWR ID	DWR_LD0003_01_s_2016_10

Comment Code					
Inspector Comment					
2007 - Getting close to the levee. Bank is clayey silt with clayey/silty toe. 2008 - Looks a little worse at the upstream end. 2009 - Some new erosion and slumping. 2010 - Some new erosion upstream of site, actively eroding at low flow. New bank swallow colony noted. 2011 - Significant erosion since last year, with an estimated 10 to 15 feet of berm lost. Large sections of the bank have slumped off. 2012 - Part of the site appears to be stabilizing, but still minor slumping in other locations. 2013 - Minor new erosion at toe. 2015: Last observed in 2013. [2015 Site ID: SAC_172-0_L] On 3/25/2016, recent high water caused river to erode to within 10-20 feet of levee toe. Appears still somewhat active.

2007 - Getting close to the levee. Bank is clayey silt with clayey/silty toe. 2008 - Looks a little worse at the upstream end. 2009 - Some new erosion and slumping. 2010 - Some new erosion upstream of site, actively eroding at low flow. New bank swallow colony noted. 2011 - Significant erosion since last year, with an estimated 10 to 15 feet of berm lost. Large sections of the bank have slumped off. 2012 - Part of the site appears to be stabilizing, but still minor slumping in other locations. 2013 - Minor new erosion at toe. 2015: Last observed in 2013. [2015 Site ID: SAC_172-0_L] On 3/25/2016, recent high water caused river to erode to within 10-20 feet of levee toe. Appears still somewhat active.

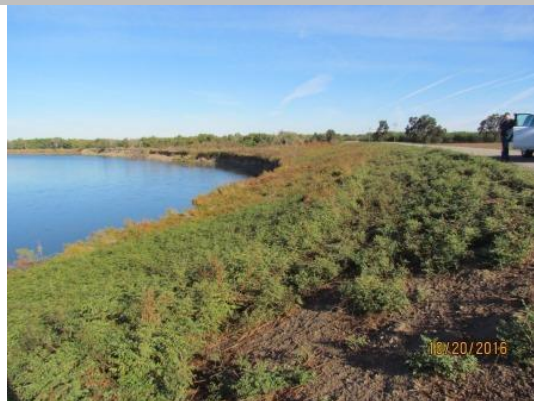
Photo 1 of 5 : FA_2016_LD0003_27_50_20161103_00112.jpg

LM Start	9.70	Rating **	U	Issue No.	50
LM End	9.70	Issue Type +	Ma	Location *	WS
Category	Earthen Levee			GPS Latitude/Longitude	
				Start	End
Item	Erosion / Bank Caving			39.505435 °	39.505435 °
				-121.984172 °	-121.984172 °
DWR ID	DWR_LD0003_01_f_2014_50				
Comment Code					
E2 : Schedule repair of erosion site prior to the next inspection.					
Inspector Comment					
Repair the erosion along the waterside toe. On 3/25/2016, recent high water caused river to erode to within 10-20 feet of levee toe. Appears still somewhat active.

View of the erosion along the waterside toe. Same site as the USACE erosion issue. Photo: 10/20/2016

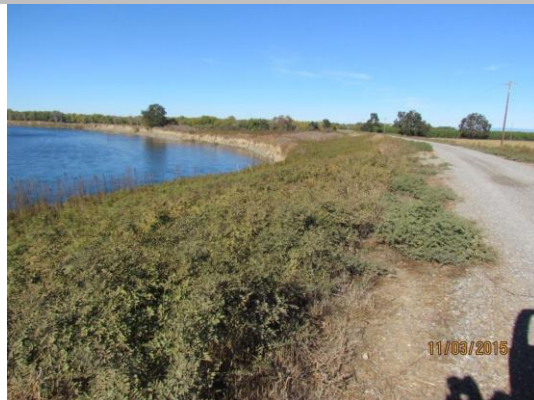
Photo 2 of 5 : FA_2016_LD0003_27_50_20160823_00030.jpg

View of the erosion along the waterside toe. Same site as the USACE erosion issue.

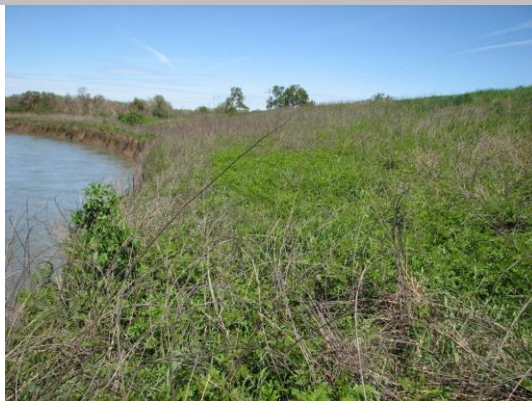
Photo 3 of 5 : FA_2016_LD0003_27_50_20160823_00029.jpg

LM Start	9.70	Rating **	U	Issue No.	50 (cont)
LM End	9.70	Issue Type +	Ma	Location *	WS
Category	Earthen Levee			GPS Latitude/Longitude	
				Start	End
Item	Erosion / Bank Caving			39.505435 °	39.505435 °
				-121.984172 °	-121.984172 °
DWR ID	DWR_LD0003_01_f_2014_50				
Comment Code					
E2 : Schedule repair of erosion site prior to the next inspection.					
Inspector Comment					
Repair the erosion along the waterside toe. On 3/25/2016, recent high water caused river to erode to within 10-20 feet of levee toe. Appears still somewhat active.

View of erosion along the waterside toe. Same site as the USACE erosion issue. Photo 3/25/2016

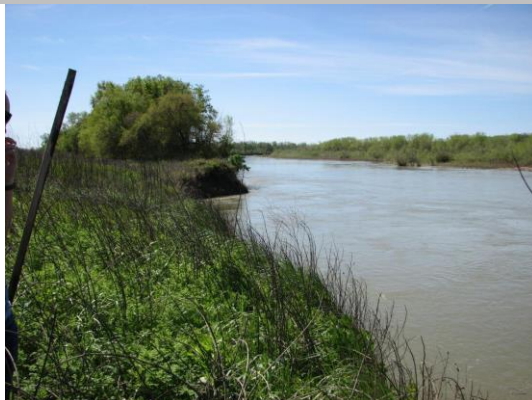
Photo 4 of 5 : FA_2016_LD0003_27_50_20160823_00028.jpg

View of erosion along the waterside toe, downstream. Same site as the USACE erosion issue. Photo 3/25/2016

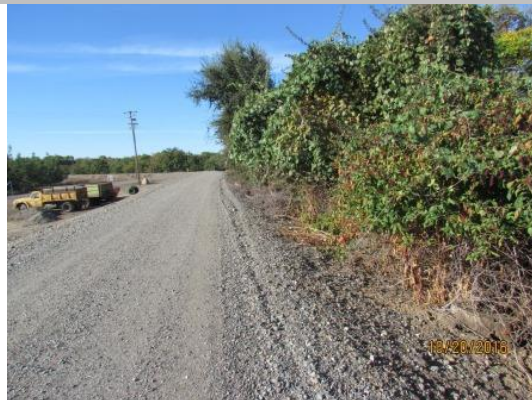
Photo 1 of 1 : FA_2016_LD0003_27_5_20161103_00115.jpg

View of the dense vegetation along the waterside slope.

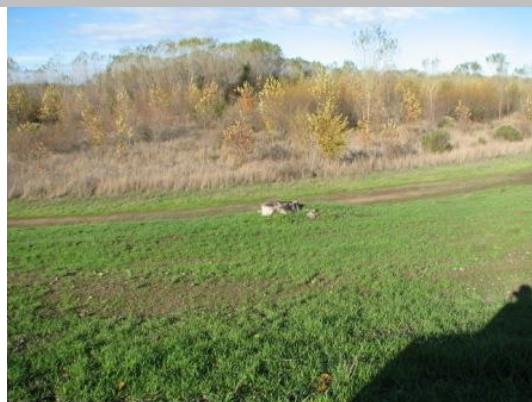
Photo 1 of 1 : FA_2016_LD0003_27_29_20160823_00017.jpg

View of the stump along the toe.

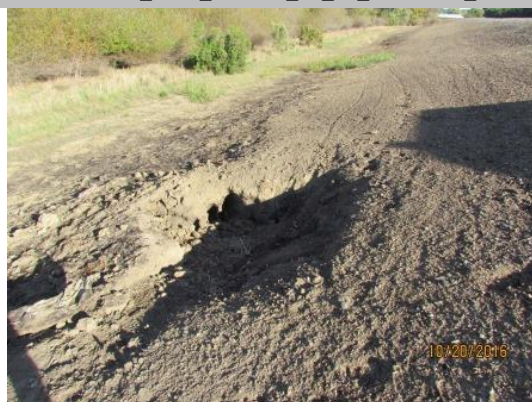
Photo 1 of 1 : FA_2016_LD0003_27_89_20161103_00116.jpg

LM Start	10.66	Rating **	U	Issue No.	89
LM End	10.66	Issue Type +	Ma	Location *	WS
Category	Earthen Levee			GPS Latitude/Longitude	
				Start	End
Item	Slope Stability			39.517553 °	39.517553 °
				-121.979132 °	-121.979132 °
DWR ID	DWR_LD0003_01_f_2016_89				
Comment Code					
S1 : Repair slope instability.					
Inspector Comment

View of a hole along the waterside slope that need to be backfilled and compacted.

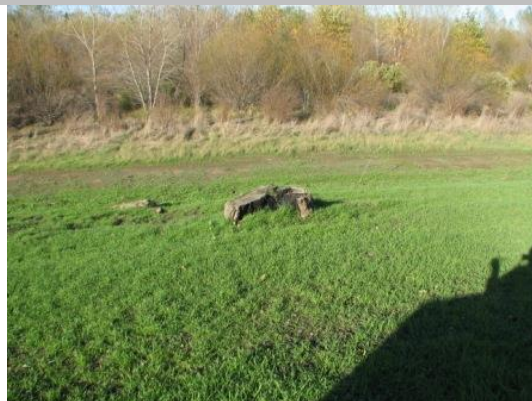
Photo 1 of 1 : FA_2016_LD0003_27_30_20160823_00018.jpg

View of the stump along the slope.

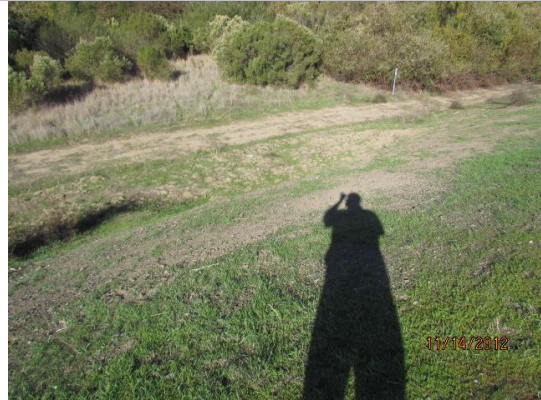
Photo 1 of 1 : FA_2016_LD0003_27_6_20160823_00003.jpg

LM Start	11.04	Rating **	M	Issue No.	6
LM End	11.04	Issue Type +	Ma	Location *	WS
Category	Earthen Levee			GPS Latitude/Longitude	
				Start	End
Item	Slope Stability			39.522921°	39.522921°
				-121.979172°	-121.979172°
DWR ID	DWR_LD0003_01_f_2012_6				
Comment Code					
S1 : Repair slope instability.					
Inspector Comment

View of the vertical cut along the waterside toe.
